**Thermographic Inspection at**

**SMALLVILLE DPW**

**123 ANY WAY SMALLVILLE, CA 01234**

**2006-04-25**

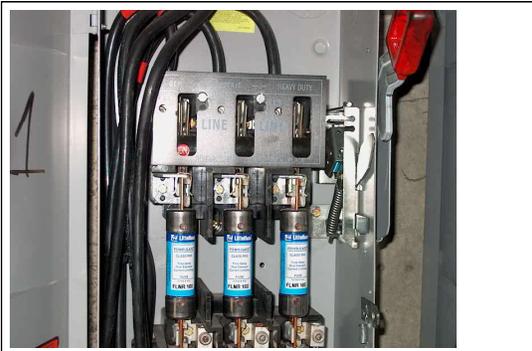
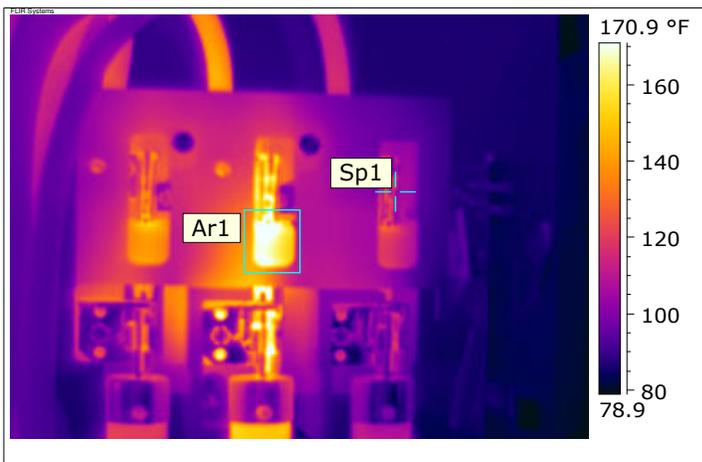
IR Text Comment	Value
Location	MAIN ELECTRIC ROOM
Equipment	FUSED DICONNECT LPA
Type	GENERAL ELECTRIC
Nom load	100
Actual load	23
Fault	4
Recommendation	REPLACE

Label	Value
Sp1	105.4 °F
Ar1: Max	191.3 °F
<b>Temp rise (Ar1 - Sp1)</b>	<b>85.9 °F</b>

**B PHASE DISCONNECT SWITCH BLADE/BLADE PORT HAS A 85.9 DEGREE RISE  
DUE TO THE LARGE DELTA T AND LOW LOAD IT IS RECOMMENDED THAT THIS SWITCH BE  
REPLACED.**

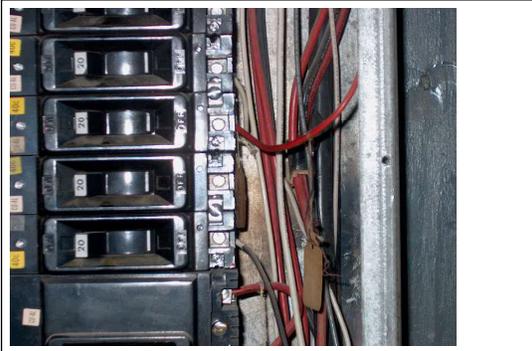
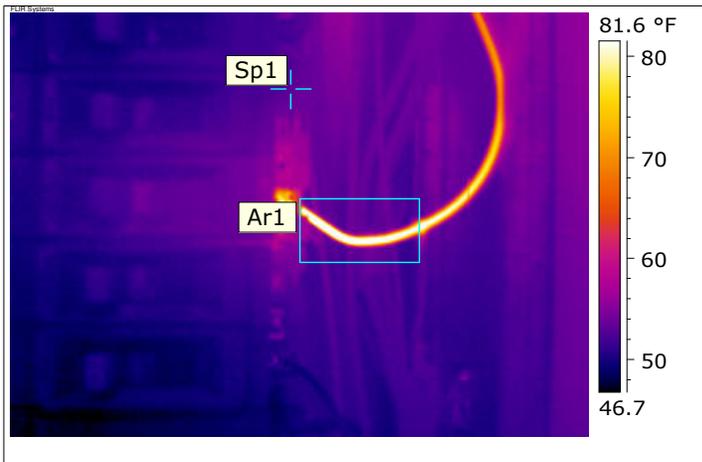
IR Text Comment	Value
Location	1ST FLOOR ELECTRIC ROOM
Equipment	PANELBOARD LP-2A
Nom load	20
Actual load	6.4
Fault	3
Recommendation	Repair

Label	Value
Sp1	53.6 °F
Ar1: Max	91.8 °F
<b>Temp rise (Ar1 - Sp1)</b>	<b>38.2 °F</b>

**HIGH RESISTANCE CONNECTION**  
**CLEAN AND TIGHTEN ALL RELATED CONNECTIONS**

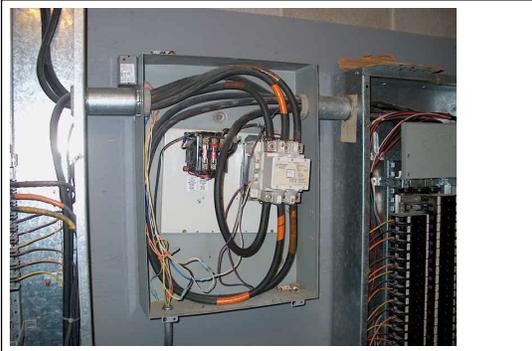
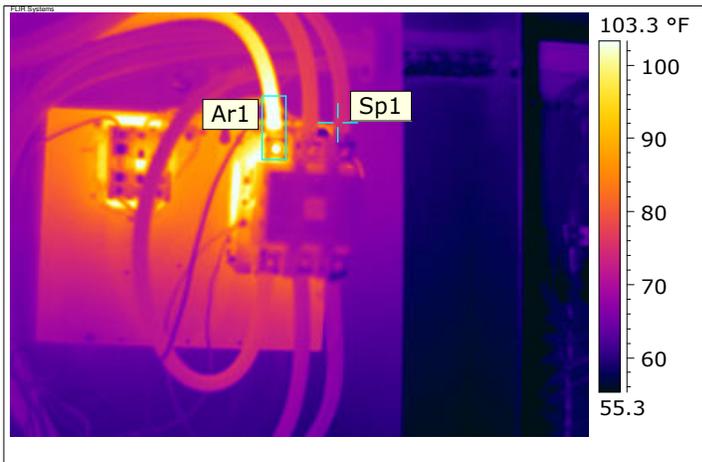
IR Text Comment	Value
Location	PARKING DECK ELECTRIC CLOSET
Equipment	LIGHTING CONTACTOR
Nom load	100
Actual load	37
Fault	3
Recommendation	Repair

Label	Value
Sp1	74.6 °F
Ar1: Max	114.2 °F
<b>Temp rise (Ar1 - Sp1)</b>	<b>39.6 °F</b>

**HIGH RESISTANCE CONNECTION**

**REMOVE LUG AND CLEAN AND TIGHTEN ALL RELATED CONNECTIONS**

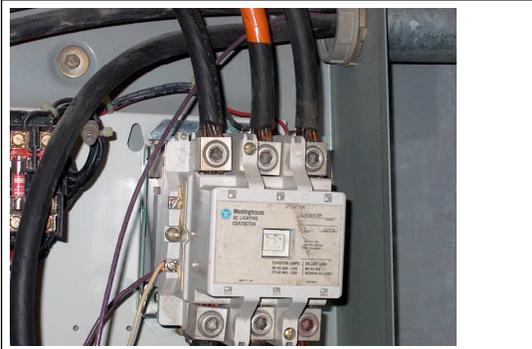
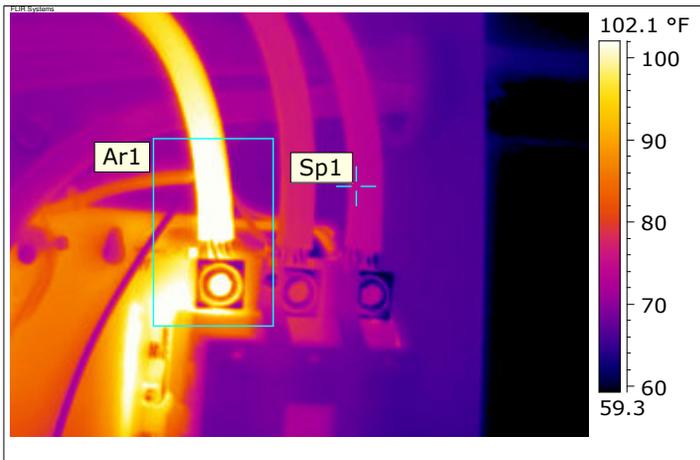
IR Text Comment	Value
Location	PARKING DECK ELECTRIC CLOSET
Equipment	LIGHTING CONTACTOR
Nom load	100
Actual load	37
Fault	3
Recommendation	Repair

Label	Value
Sp1	74.1 °F
Ar1: Max	115.1 °F
<b>Temp rise (Ar1 - Sp1)</b>	<b>40.9 °F</b>

**HIGH RESISTANCE CONNECTION**

**REMOVE LUG AND CLEAN AND TIGHTEN ALL RELATED CONNECTIONS**

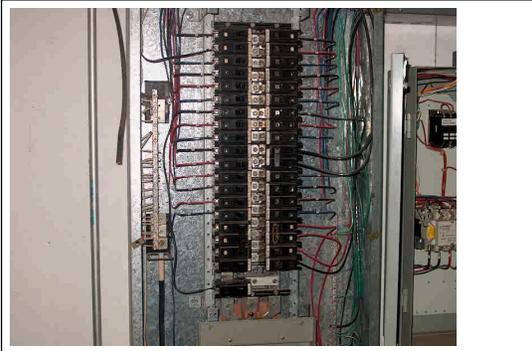
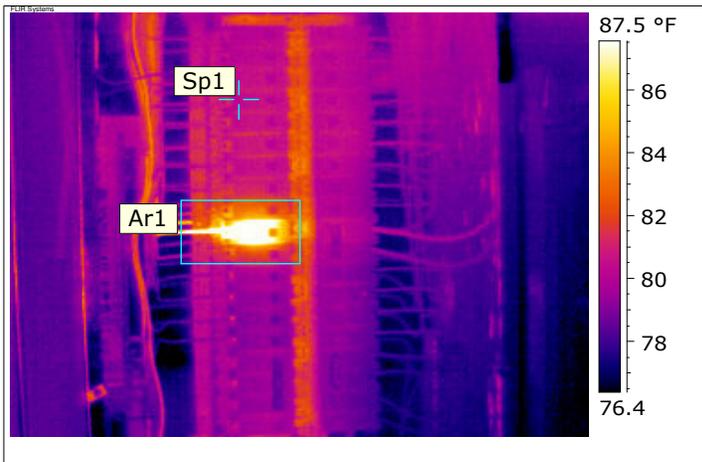
IR Text Comment	Value
Location	2ND FLOOR ELECTRIC ROOM
Equipment	PANELBOARD RP-3B
Nom load	20
Actual load	19.3
Fault	2
Recommendation	Repair
PROBLEM	OVERLOAD

Label	Value
Sp1	80.3 °F
Ar1: Max	93.2 °F
<b>Temp rise (Ar1 - Sp1)</b>	<b>12.9 °F</b>

**LOAD EXCEEDS 80% OF BREAKER RATING**  
**REDUCE LOAD BELOW 80% OF 20 AMPS**

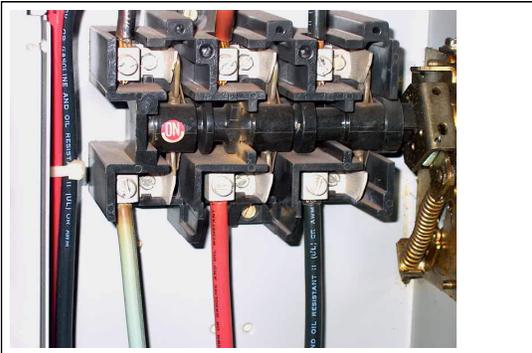
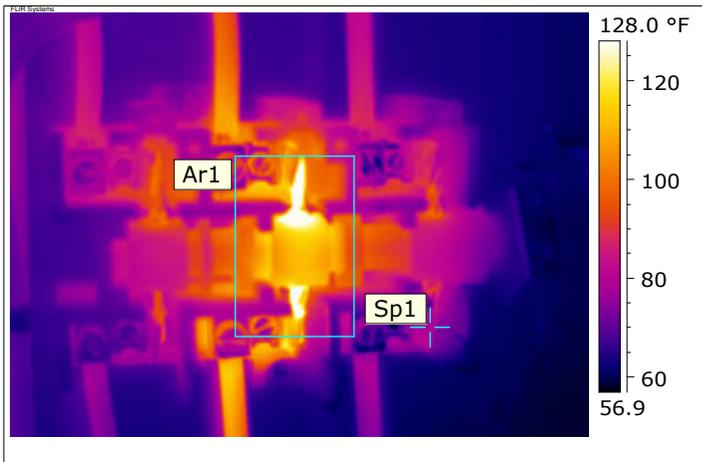
IR Text Comment	Value
Location	PENTHOUSE
Equipment	DISCONNECT SWITCH
Nom load	100
Actual load	22
Fault	3
Recommendation	Repair
PROBLEM	CONTACT AREA WORN/LOOSE

Label	Value
Sp1	78.6 °F
Ar1: Max	146.4 °F
<b>Temp rise (Ar1 - Sp1)</b>	<b>67.8 °F</b>

**HIGH RESISTANCE CONNECTION**

**NOTE DISCOLORED WIRE A PHASE LOAD SIDE**

**CLEAN BLADE AND BLADE PORT SURFACES AND CHECK BLADE PORT TENSION.**

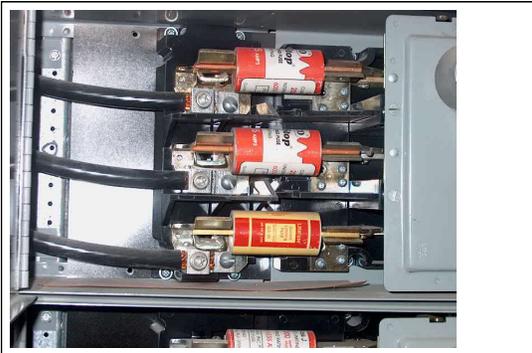
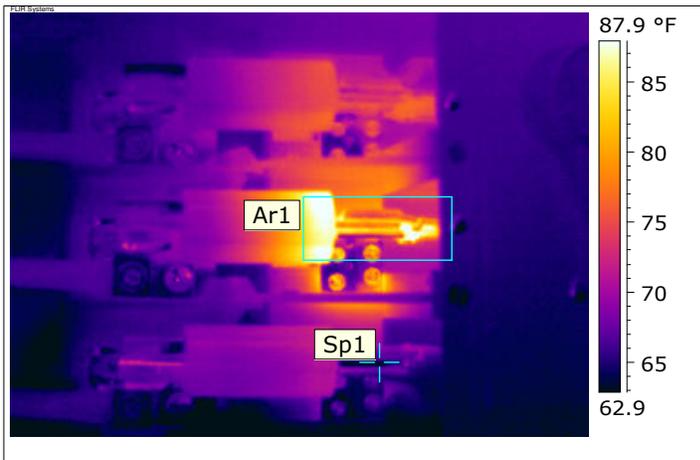
IR Text Comment	Value
Location	PENTHOUSE
Equipment	FUSED DISCONNECT SWITCH P-3
Nom load	100
Actual load	41
Fault	2
Recommendation	Repair

Label	Value
Sp1	63.0 °F
Ar1: Max	92.3 °F
<b>Temp rise (Ar1 - Sp1)</b>	<b>29.3 °F</b>

**HIGH RESISTANCE CONNECTION**

**CLEAN BLADE AND BLADE PORT SURFACES AND CHECK BLADE PORT TENSION.**
