Thermographic Inspection at

ABC Corporation

March 5, 2025

Certified Infrared Inc.

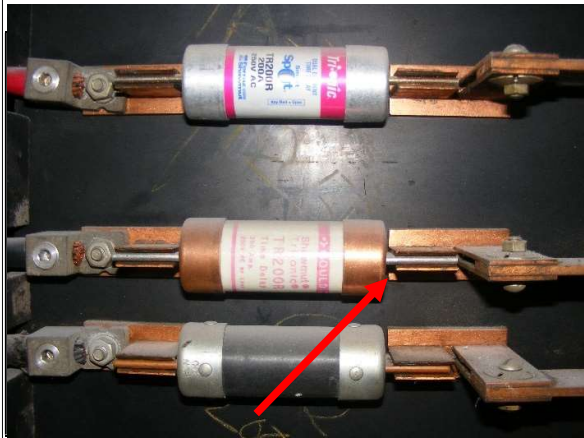
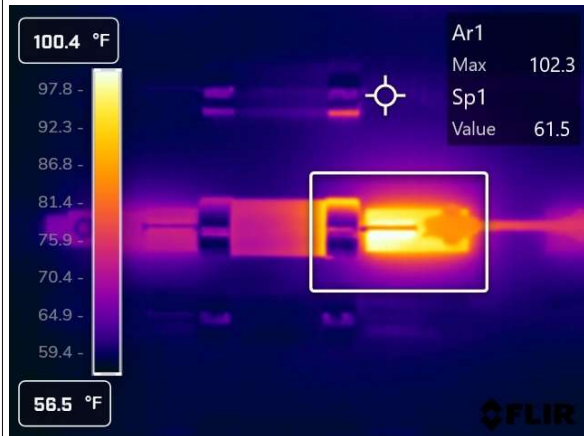
Photo 1

Location	2 nd Floor, Main Switch Gear Room
Equipment Type	Switchboard
Equipment Name	Panel P-CB
Equipment Size	200a, 277/480v
Problem Item	Fuse Clip
Fault Level	3
Actual Load (A)	A: 35.2, B: 34.7, C: 34.6

Sp1 Temperature	61.5 °F
Ar1 Temperature	102.3 °F
Temperature Rise	40.8°F

C Phase, Line Side

Loose fuse jaws / clips. Remove fuse. Clean contact area of fuse. Adjust spring tension if applicable and/or replace fuse jaws/clips.

High resistance connection. Clean and tighten all related connections.

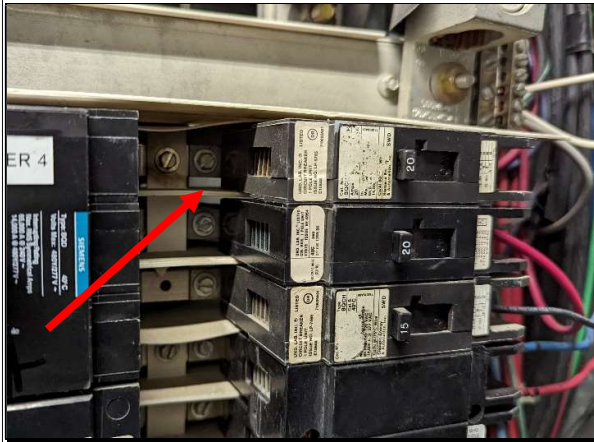
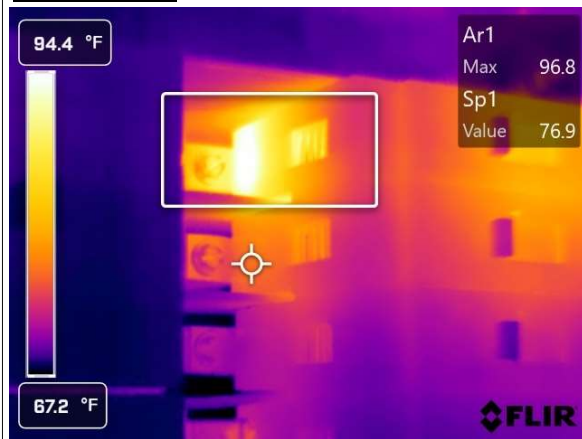
Photo 2

Location	20 th Floor, North Gym Electrical Room
Equipment Type	Panelboard
Equipment Name	H6
Equipment Size	400a, 120/208v
Problem Item	Circuit 2
Fault Level	2
Actual Load (A)	A: 16.0 B: 16.0, C: 0.2

Sp1 Temperature	76.9 °F
Ar1 Temperature	96.8 °F
Temperature Rise	19.9 °F

A Phase, Line Side

Note: Visible Scorch mark on panel bus.

Internal Breaker Problem. Replace breaker.

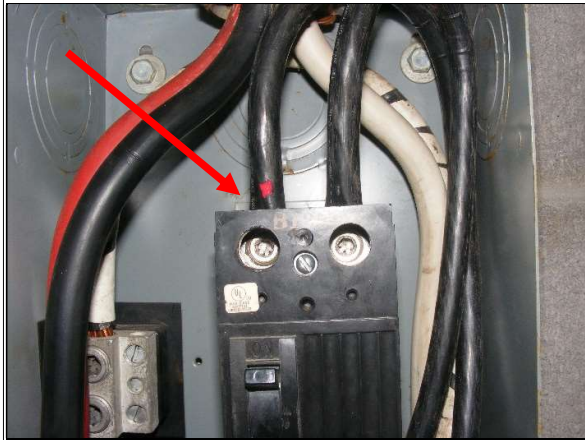
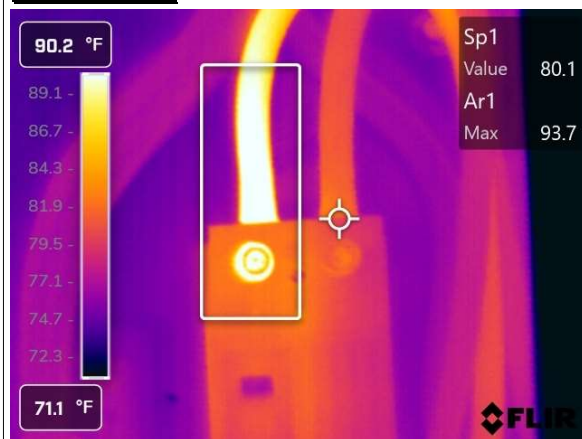
Photo 3

Location	18 th Floor, Control Room
Equipment Type	Breaker
Equipment Name	BKT4A
Equipment Size	225a, 240v
Problem Item	Terminal Connection Phase A
Fault Level	2
Actual Load (A)	A: 21, B: 24

Sp1 Temperature	80.1 °F
Ar1 Temperature	93.7 °F
Temperature Rise	13.6°F

A Phase, Line Side.

Loose wire connection. Disassemble, inspect lug and cable end. Clean, reassemble, and torque to proper specification.

High resistance connection. Clean and tighten related connection.

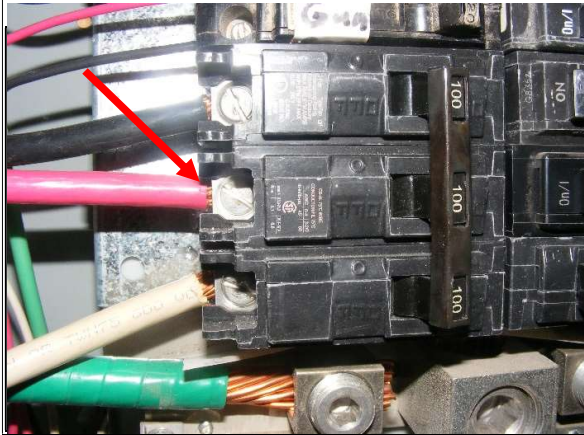
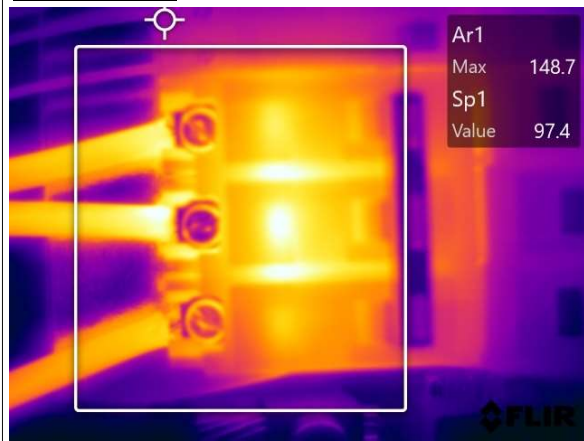
Photo 4

Location	9 th Floor, Electrical Room A
Equipment Type	Panelboard
Equipment Name	H1A
Equipment Size	400a, 120/208v
Problem Item	Breakers 33, 35, 37
Fault Level	3
Actual Load (A)	A: 100.7, B: 102.1, C: 102.2

Sp1 Temperature	97.4 °F
Ar1 Temperature	148.7 °F
Temperature Rise	51.3 °F

A, B, & C Phases, Load Side.

Overload. Load on circuit should be reduced.

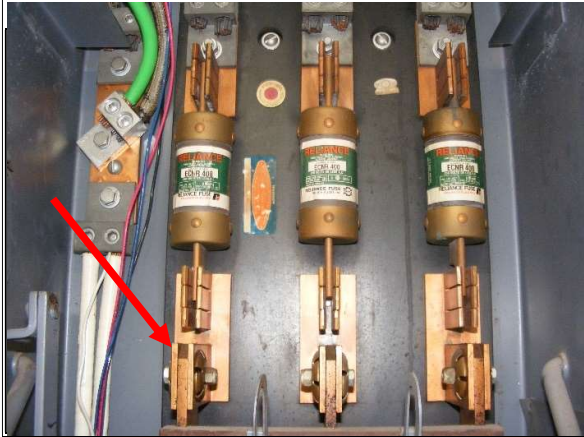
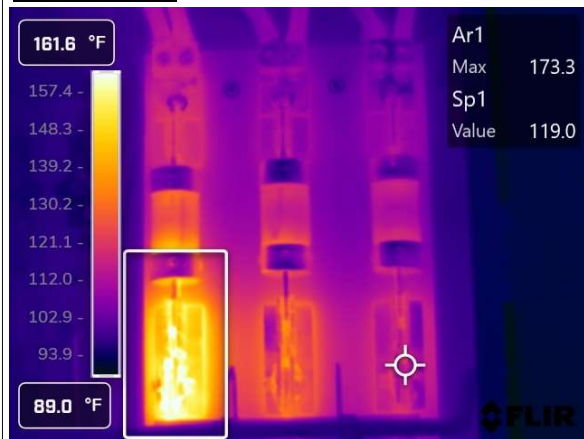
Photo 5

Location	7 th Floor, Distribution Switch Gear Room
Equipment Type	Fused Disconnect Switch
Equipment Name	LP-3C
Equipment Size	600a, 480v
Problem Item	Hinge Point
Fault Level	3
Actual Load (A)	A: 58, B: 62, C: 61

Sp1 Temperature	119.0 °F
Ar1 Temperature	173.3 °F
Temperature Rise	54.3 °F

A Phase, Line Side

Pivot (Hinge) point of switch is loose. Disassemble, inspect, clean and adjust tightness of hinge point.

High Resistance Connection. Clean and tighten all related connections.

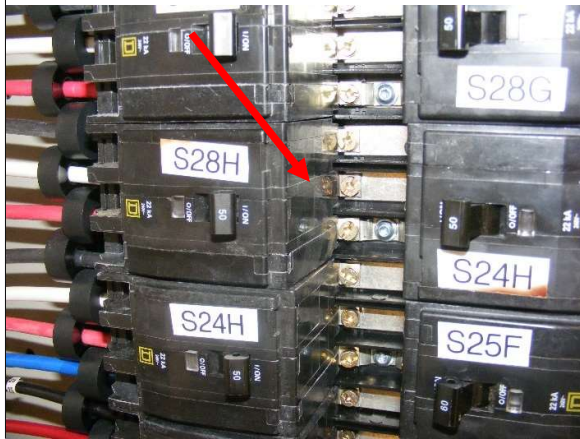
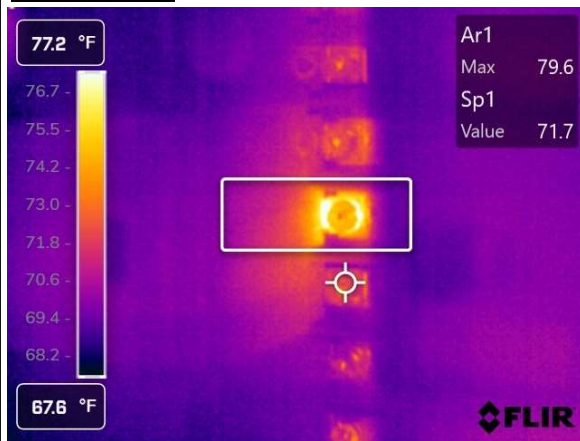
Photo 6

Location	2 nd Floor, Server Room
Equipment Type	Power Distribution Unit
Equipment Name	2CV
Equipment Size	225a, 120/208v
Problem Item	Breaker 13, S28H
Fault Level	2
Actual Load (A)	A: 12.1, B: 12.0, C: 11.7

Sp1 Temperature	71.7 °F
Ar1 Temperature	79.6 °F
Temperature Rise	7.9

Line Side.

Poor panel bus connection. Remove breaker, clean bus area, check tightness of connection and reinstall. Replace breaker if necessary.

High resistance connection. Clean and tighten all related connections.

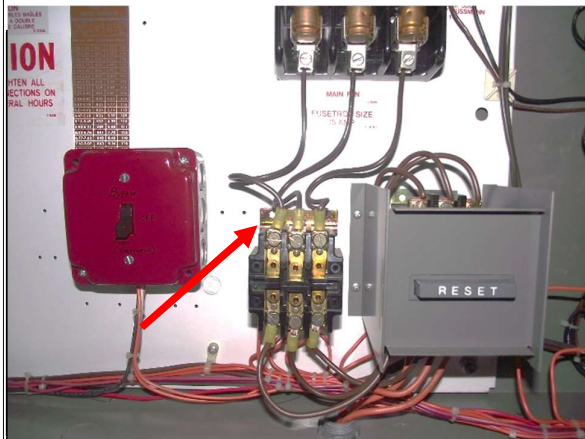
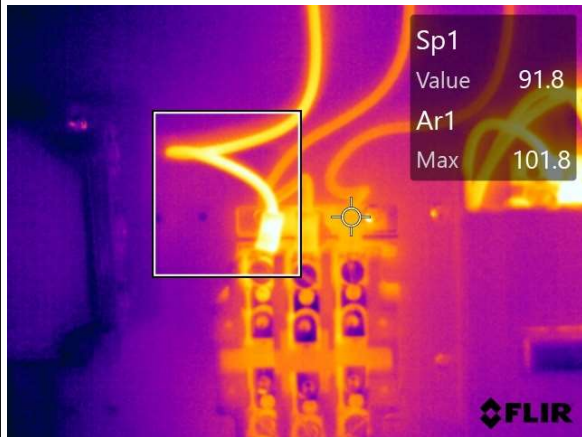
Photo 7

Location	2 nd Floor, Server Room
Equipment Type	CRAC
Equipment Name	SC-3-12
Equipment Size	15a, 480v
Problem Item	Thermal Block
Fault Level	2
Actual Load (A)	A: 8.0, B: 8.1, C: 8.0

Sp1 Temperature	91.8 °F
Ar1 Temperature	101.8 °F
Temperature Rise	10.0 °F

A Phase

Thermal block off fuse labeled 'main fan'.

Bad wire terminal. Redo crimp connection and retorquing connection.

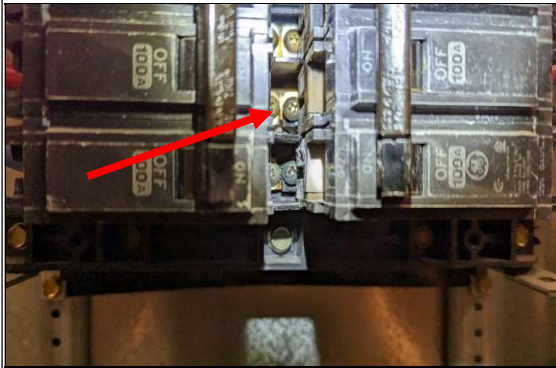
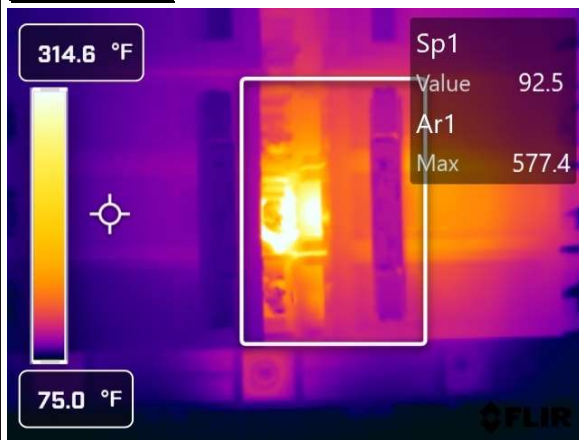
Photo 8

Location	19 th Floor, Electrical Room (A)
Equipment Type	Panelboard
Equipment Name	P1-B
Equipment Size	400a, 120/208v
Problem Item	Circuit 18
Fault Level	4
Actual Load (A)	A: 17.2, B: 17.0, C: 8.7

Sp1 Temperature	92.5 °F
Ar1 Temperature	577.4 °F
Temperature Rise	484.9 °F

Phase C, Line Side.

Poor panel bus connection. High resistance connection. Breaker is compromised and should be replaced. Inspect panel bus for damage.
